AN EXAMPLE OF THE CONSERVATION OF “DEDE TOMBS”, THE SYMBOLS OF ALEVI- BEKTASHI CULTURE ISPARTA – İSMAIL DEDE TOMB

Ayşe Betül GÖKARSLAN *
Duygu KÖSE**

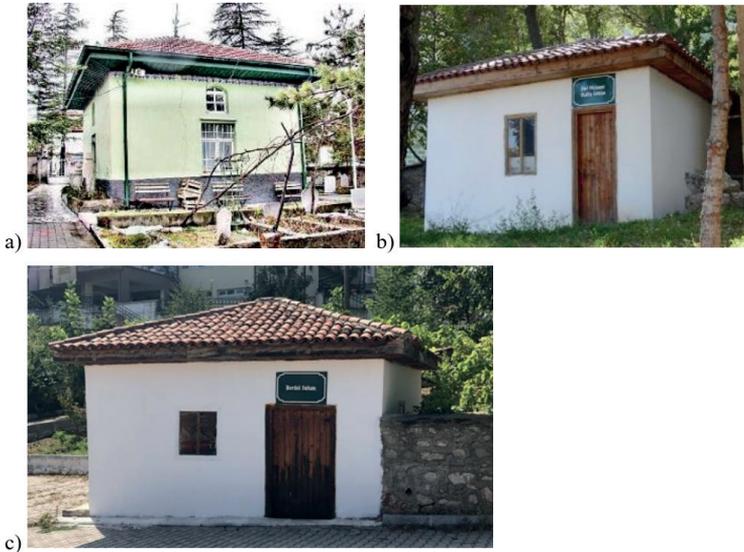
Figure 1. a) Aldan Dede Tomb, b) Piri Mehmet Halife Sultan Tomb c) Berdai Sultan Tomb

Baba Türbesi, Uluborlu Ahi Şemseddin Türbesi, and Yalvaç Şeyh Mehmet Türbesi (Anonymous, 2009). The architectural styles of these tombs vary significantly. Tombs with sophisticated architecture are mainly polyhedral tombs dating back to the Seljuk or Beylik periods. Within the rectangular or square tombs, there are also tombs reflecting the architectural characteristics of their respective periods. For instance, Şeyh Muslihiddin Türbesi, located on Yeşil Ada in Eğirdir, is a tomb of historical significance despite various deteriorations. However, among the polyhedral tombs, there are tombs built in recent times that do not possess sophisticated architectural features, such as the renovated Gönen Yunus Emre and Eğirdir Devran Dede Tombs using reinforced concrete construction techniques. The architectural styles of these tombs vary significantly. Tombs with sophisticated architecture are mainly polyhedral tombs dating back to the Seljuk or Beylik periods. Within the rectangular or square tombs, there are also tombs reflecting the architectural characteristics of their respective periods. For instance, Şeyh Muslihiddin Tomb, located on Yeşil Ada in Eğirdir, is a tomb of historical significance despite various deteriorations. However, among the polyhedral tombs, there are tombs built in recent times that do not possess sophisticated architectural features, such as the renovated Gönen Yunus Emre and Eğirdir Devran Dede Tombs using reinforced concrete construction techniques (Figure 1, 2, 3, 4).

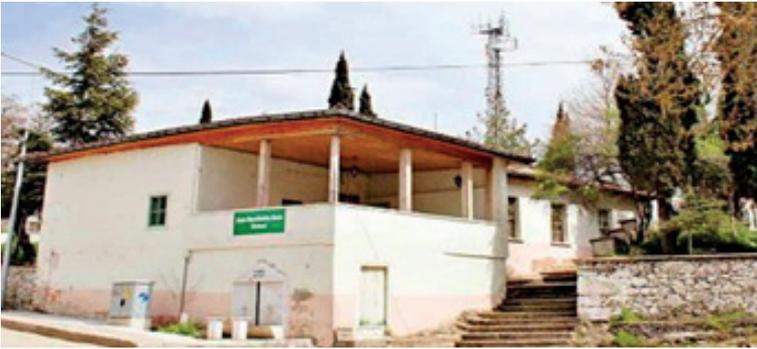
Figure 3. Eğirdir Şeyh Muslihiddin Tomb

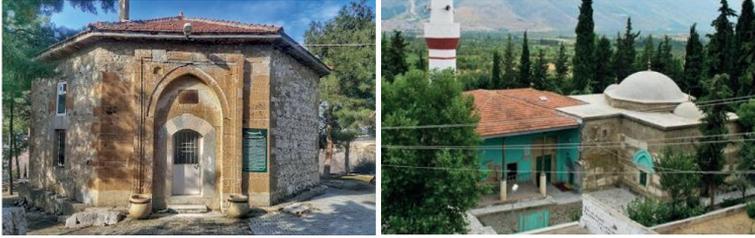
Figure 7. Gönen Gümüşgün Sinan Dede Tomb and Senirkent Uluğbey (İlegüp) Veli Baba Tomb

- Sinan Dede Tomb, Tapduk and Yunus Emre Tomb in Gönen-Gümüşgün Village, and a tomb thought to belong to Yunus Emre in Güneykent Town,
- Veli Baba Sultan Tomb in Uluğbey (İlegüp) Village of Senirkent District,
- Aslan Baba Tomb (Aşağı Tekke), Elyaz Tekke Tomb, İsmail Dede Tomb (Yukarı Tekke), Ümmi Nine Tomb in Yakaören Village (Lavus Village),
- Sheikh Mehmet Dede and Hatip Dede Tombs in Aliköy are Alevi / Bektashi Tombs (Figure 7, 8, 9).

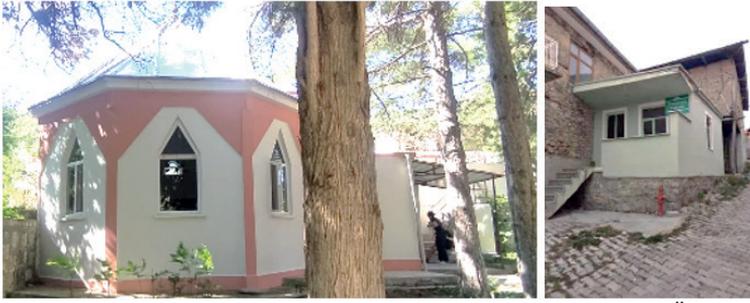
Figure 8. Isparta Yakaören Aslan Baba Tomb and Yakaören Ümmi Nine Tomb

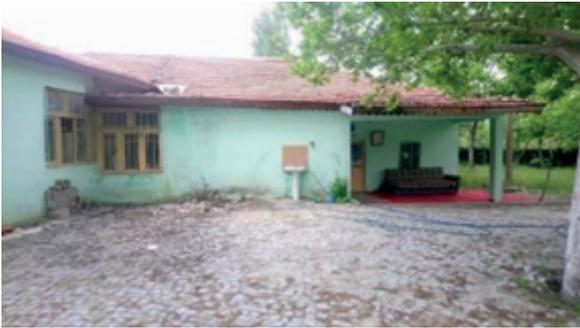
Figure 9. Tomb of Şeyh Mehmet Dede (Hatip Dede) in Aliköy

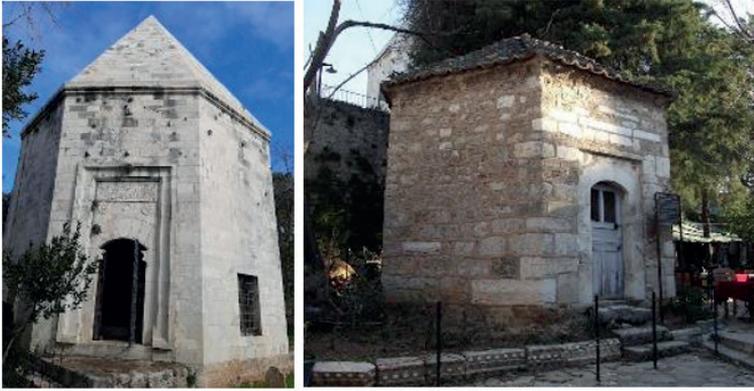
Figure 10. Zincirkiran Mehmet Bey Tomb (1377) and Nigar Hatun Tomb (15th Century)

interred there. Rituals, including the tradition of lighting candles, which are part of the religious belief, continue to be practiced in some tombs today (Erdenk, 2001). Examples of octagonal-plan tombs in Antalya, such as the Sinan Dede Tomb, were examined. These; Zincirkiran Mehmet Bey Tomb (1377), Nigar Hatun Tomb (15th Century), Elmalı, Abdal Musa Sultan Tomb (14th Century) (Figure 10, 11). None of these tombs have the aspect ratio, materials and construction techniques of Sinan Dede Tomb. The body walls made of rubble stone in the Sinan Dede Tomb have a larger mass. This suggests that the building was built as a dervish lodge, as written in the registration file.

When examining octagonal-plan tombs in Antalya, none of them match the size, materials, and construction technique of the İsmail Dede Tomb. İsmail Dede Tomb stands out with its massive rubble stone masonry and large body walls compared to the examples found in Antalya. The substantial width of the body walls is believed to be associated with the intended use of the structure as a *dergah*, as mentioned in the registration files. In this comparison, examples like Zincirkıran Mehmet Bey Tomb (1377), Nigar Hatun Tomb (15th century), and Elmalı, Abdal Musa Sultan Tomb (14th century) in Antalya were considered.

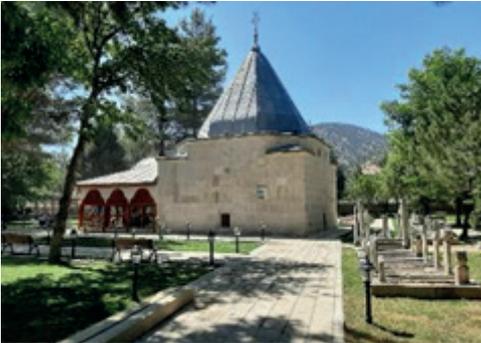
Figure 11. Elmalı, Abdal Musa Sultan Tomb (14th Century)

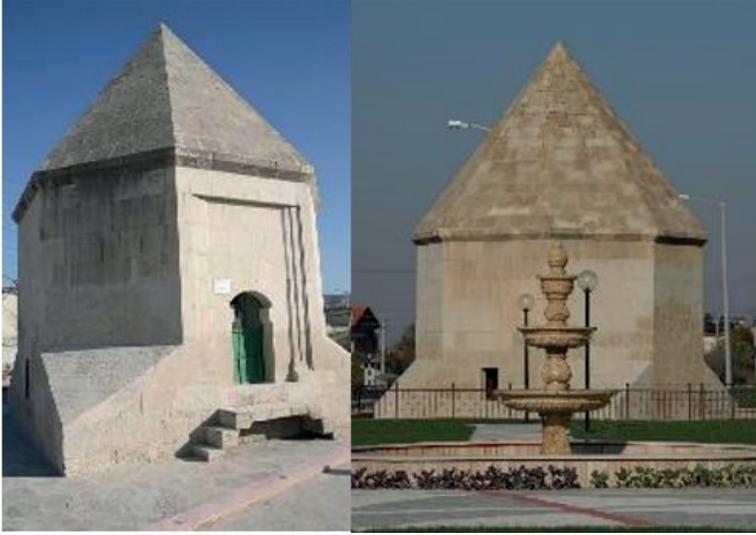
Figure 12. Burdur Hıdırlık Kümbeti or Dörtayak Tomb (14-15th Century)

The examples of octagonal-plan tombs in Burdur, similar to the Sinan Dede Tomb, have been examined. These include the Hıdırlık Kümbeti / Dörtayak Tomb (14-15th century) and the Veli Dede Tomb (14th century) (Figure 12, 13). Although these tombs have an octagonal plan like the tombs in Antalya, they differ from the Sinan Dede Tomb in terms of their facades and structures. The fact that the Hıdırlık Kümbeti / Dörtayak Tomb is built from dimension stone, and the Veli Dede Tomb has wooden beams and niches on its facades, distinguishes both structures.

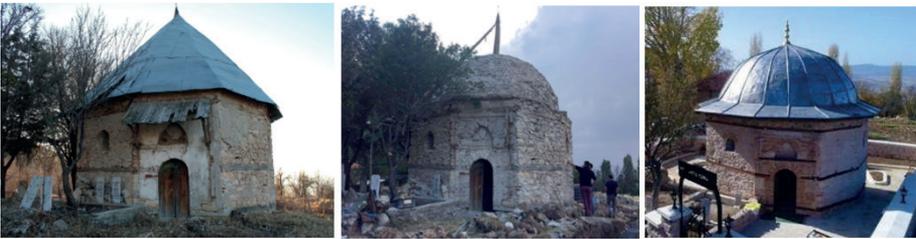
Figure 13. Burdur Veli Dede Tomb (14th Century)

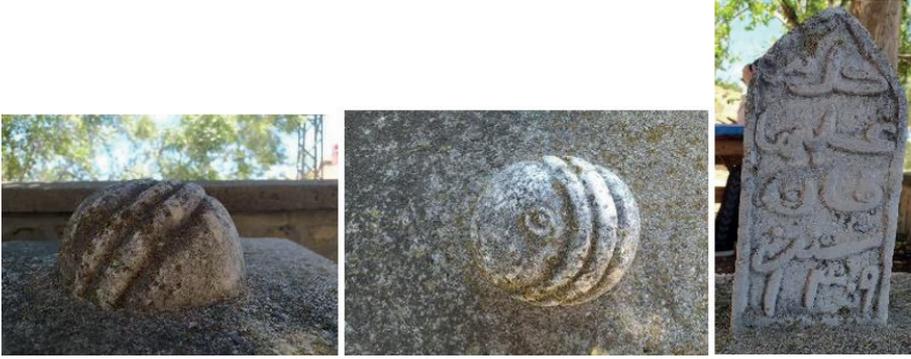
Figure 15. Tombstone and grave turban belonging to the person thought to be the assistant of the İsmail Dede

Dede Tomb in Lagus Village (Yakaören) but did not provide any information about its historical date (Böcüzade, 2012). Yasin Erdenk stated that the tomb contains the tombstone of Şeyh İsmail Efendi, dated to 1617 AD (1026 AH) (Erdenk, 2001). However, this information was not verified during the survey work. In the garden, there is a grave that is said to belong to the assistant of the dede, but it does not align with the historical period in which Yasin Erdenk mentioned İsmail Dede. The grave is marked with a stone headgear and a gravestone inscribed with the date 1891 AD (1309 AH) (Figure 15).

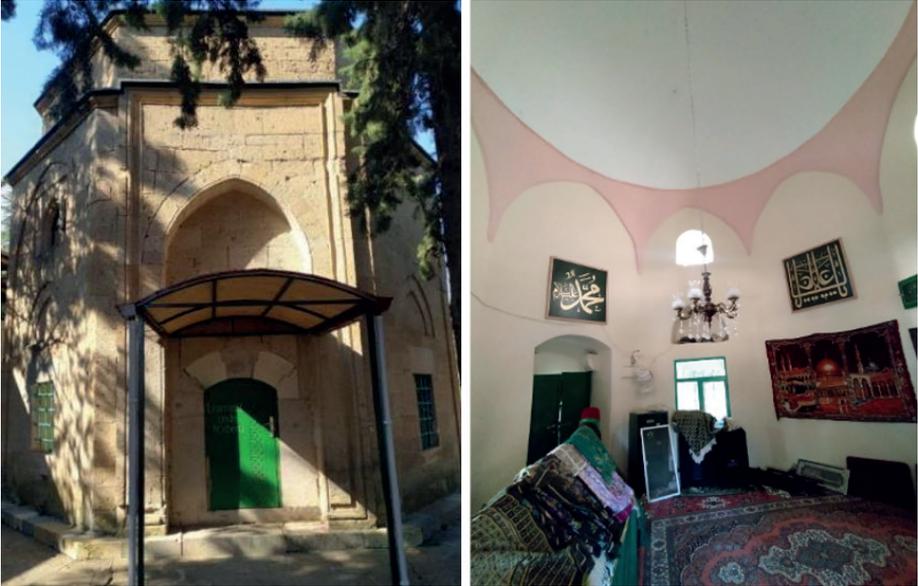
Figure 16. The Entrance Facade and Interior of the Tomb

The İsmail Dede Türbe is located in the Yakaören Village of the central district in Isparta province, Turkey. It is situated on parcel 12 of lot 113 in map 12 and is registered as state property. The structure has an octagonal floor plan and is currently covered with a lead dome. It is built upon an octagonal stone platform that conforms to the plan typology. The single-story building is accessed through a pointed arch and convex-molded crown door located on the west facade (Figure 16).

The upper-level blind pointed arch and convex profiles that make up the crown door are made of köfke stone, while the lower-level flat-arch system that forms the doorway is constructed from marble. There are two entrance doors. The exterior door frame is not original, being a single-wing wooden frame, while the inner door is original and made of wood. The entrance facade and all other facades are constructed as flush-jointed, smoothly cut ashlar stone walls. There are window openings at

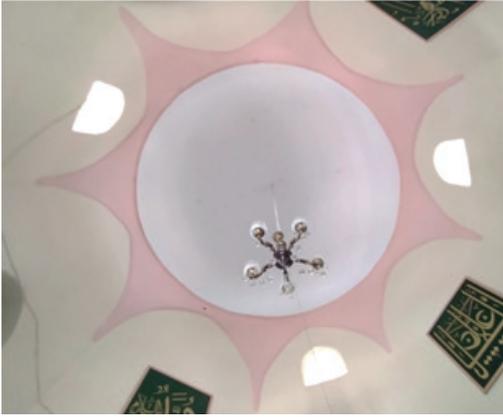
Figure 17. Ceiling covering in interior

different levels on the northeast, northwest, southeast, south, and southwest facades of the structure. On the northwest, northeast, and south facades, there are pointed arch windows at the upper level, while on the northeast, northwest, southeast, and southwest facades, the window openings at the lower level are rectangular in shape with smooth-dimension stone lintels. The body walls of the structure are approximately 100 cm in width, and this measurement approaches around 120 cm at the wall junctions where the cornerstones are placed. Inside the space, to the south, along the southeast-northwest axis, there is a sarcophagus belonging to Ismail Dede. In addition, there is a painted application on the dome's interior ceiling (Figure 17). Due to its octagonal plan scheme, there is no inscription on the structure, which resembles the plan typology of Seljuk tombs. When examining the nearby tomb structures, it is not possible to identify a common typology for a tomb. However, in terms of its plan and facade design, the structure shares similarities with the Sinan Dede Tomb located in Gümüşgün Village in Gönen district.

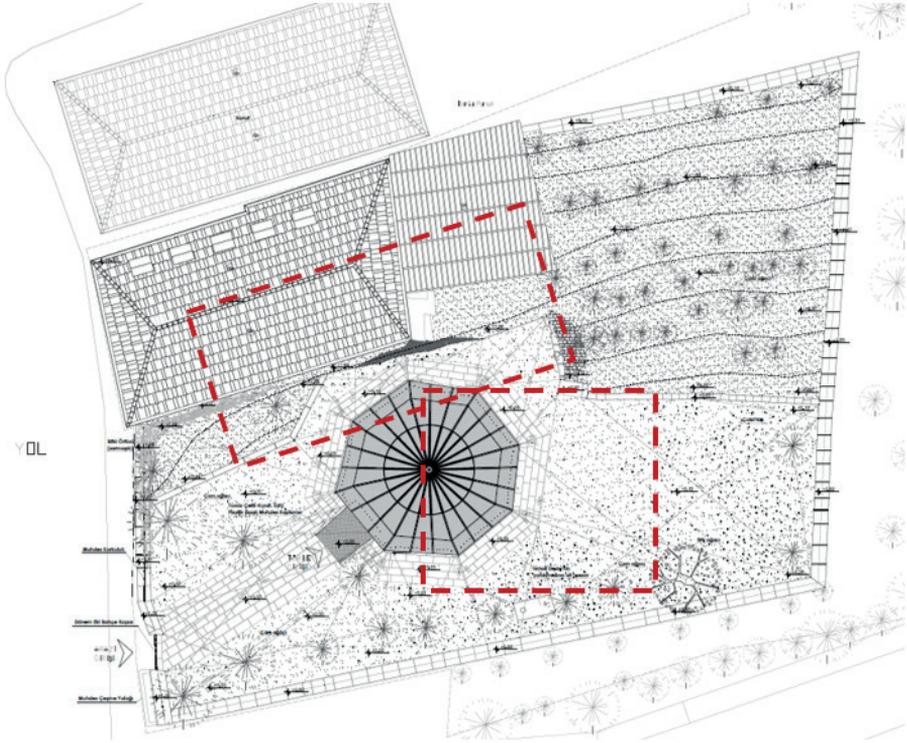
Figure 18. Site Plan

The tomb is located within the same parcel as the cemetery. Positioned near the center of the plot, to the north, there is a building with a function related to Alevi culture. Additionally, to the south of the tomb, there is one grave belonging to İsmail Dede’s assistant (Figure 18).

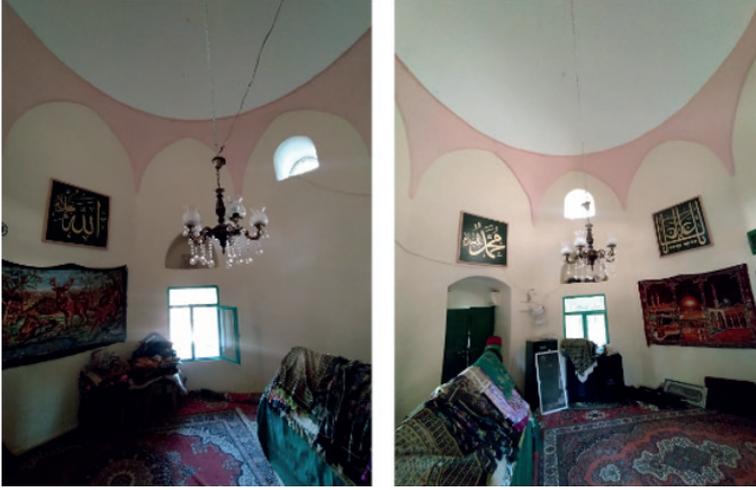
Figure 19. Interior

The tomb is situated on a level ground without any noticeable slope. Entry to the single-story İsmail Dede tomb is provided through the crown door on the west facade, leading to the tomb space, which consists of a single volume. When entering the tomb space, there is a sarcophagus extending along the southeast-northwest axis to the south. Inside the interior, there is no mihrab detail on any wall, while niches are present above the window openings at the lower level of the northeast, northwest,

southeast, and southwest body walls. To the northwest of the sarcophagus, there is a lid on the floor, beneath which, there is a vertical earthen pit in which a baked clay künkün related to Alevi culture's ritual is placed (Figure 19, 20, 21).

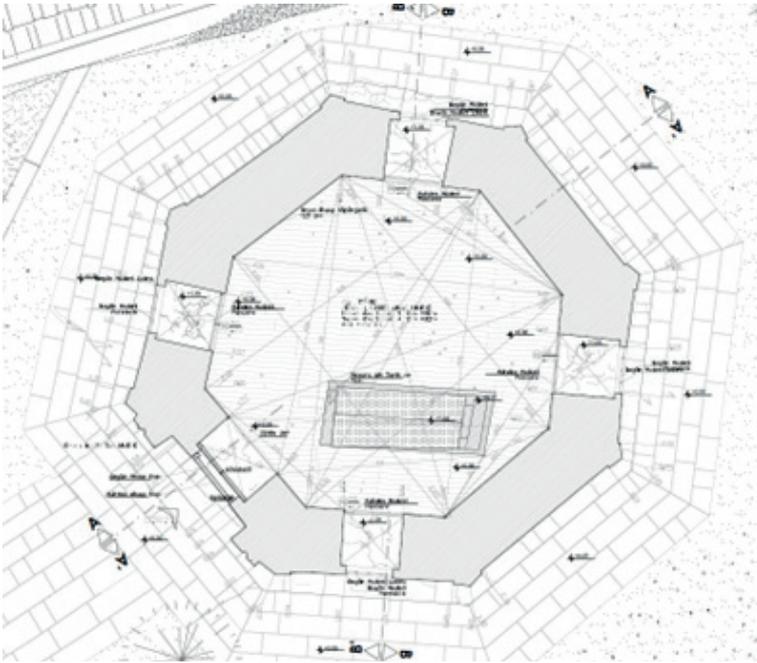
Figure 22. Tomb plan survey

and the K1 door is thought to have been added later to meet specific requirements. The window openings at the lower level of the northeast, northwest, southeast, and southwest facades of the space are rectangular in shape with straight stone lintels. These windows are original, and the metal frames are modern (Figure 19). In the sections of the lower level windows that face the exterior facade, there are original metal railings. On the northwest, northeast, and south facades, there are pointed arch windows at the upper level, and the window openings and frames are original. Surface and sills of the window openings have exhibited hairline cracks related to material deterioration.

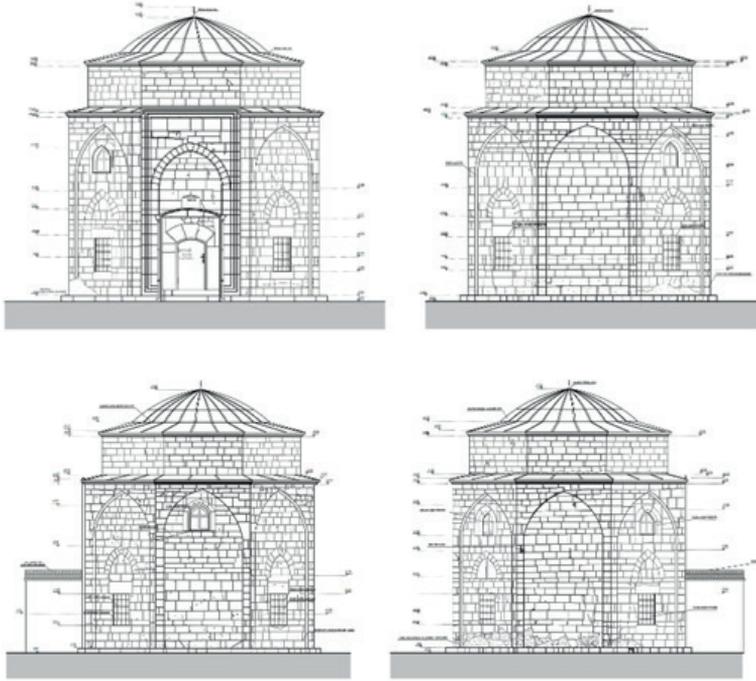
Figure 23. Survey of the western, eastern, southern and northern facades of the tomb

The single-story structure, which has eight facades, is accessed through a pointed arch door with a convex molding on the western facade. On the western facade, there is a projecting canopy over the entrance axis and door. The upper part of the crown door is made of voussoirs with blind pointed arches and convex profiles, crafted from köfke stone, while the lower part that forms the door opening is made of marble with a flat arch system (Figure 23). The existing door frame visible from the facade is not original; it is a single-wing wooden frame. The entrance facade and all other facades are constructed with smoothly cut ashlar stone masonry walls with flush-jointed seams (Figure 23). Furthermore, all facades feature pointed arch relieving arches above the lower-level windows and blind arches running along the façade above the upper-level windows. The window openings at the lower level on the northeast, northwest, southeast, and southwest facades are rectangular in shape with straight stone lintels. Additionally, the exterior-facing sections of these windows have original metal railings. On the northwest, northeast, and south facades, there are pointed arch windows at the upper level, and the window openings and frames are original (Figure 23).

The building exhibits various issues on its façades and roofing structure. It is noted that cement-based filler material is applied on the roofing structure and body walls of all façades. In addition, hairline cracks are observed on the casemate walls of the northeast and southeast sides. Furthermore, a partial color change due to improper repairs is observed above the main gate on the western facade and in the stone elements at the north, northwest, and northeast parapet levels. The western facade features an added wooden porch above the entrance axis and gate. On the northeast, southeast, south, and southwest façades, as well as right above the parapet, partial soiling is evident on the stone elements due to geographical factors. Similarly, these façades exhibit material deterioration due to rising dampness at the body walls and parapet levels. Furthermore, there is partial mortar loss on the northeast, northwest, west, and south façades, while the stone elements and joints in the blind arches of the east and north façades suffer from surface loss. The added wooden porch above the entrance axis, the wooden entrance gate, and the metalwork on the

ground floor windows exhibit deterioration related to material substitution by users. Analytical drawings illustrating the facade deterioration can be found in Appendix 2.

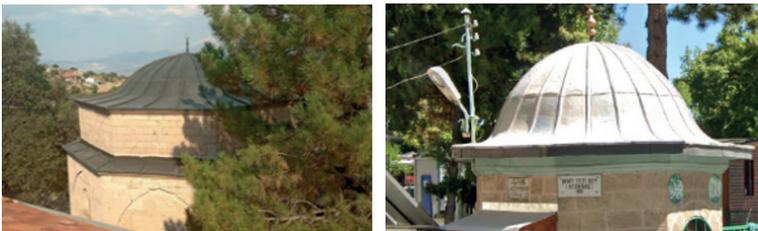
Figure 24. The lead-covered domes of İsmail Dede and Kesikbaş Tombs

In the second half of the 20th century, the Isparta Yakaören İsmail Dede Tomb and the Isparta Kesikbaş Tomb underwent renovations and are well-constructed tombs made of smooth-dimension stone with lead-covered dome roofing systems (Figure 24). İsmail Dede Tomb, with architectural facade characteristics reminiscent of the Isparta of the 1950s, is built with kövke stone, which was used in public buildings such as the Government Mansion, Mimar Sinan Mosque, and the Grand Mosque. Although both tombs have lead-covered domes as their top covers, İsmail Dede Tomb features a two-tiered roof system with an octagonal cornice transition to the dome (Table 1).

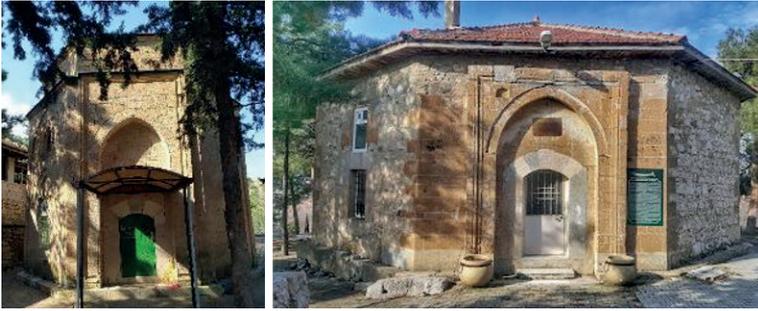
Figure 25. Entrance of İsmail Dede and Sinan Dede Tombs

When comparing the entrances of the tombs, it is observed that only İsmail Dede Tomb and Sinan Dede Tomb have a portal and a marble-arched doorway (Figure 25). The flat archway, designed in white marble, is framed with smooth-cut kövke stone to create a portal (crown door) in both tombs. The tall pointed arch forms the crown door, enclosed within a rectangular frame with a fluted molding on the outermost layer. Both tombs have spaces for inscriptions but do not have inscriptions themselves. The high-pointed arch on the entrance facade is constructed from köfke stone, while the lower flat-arched doorway is made of marble (Table 1).

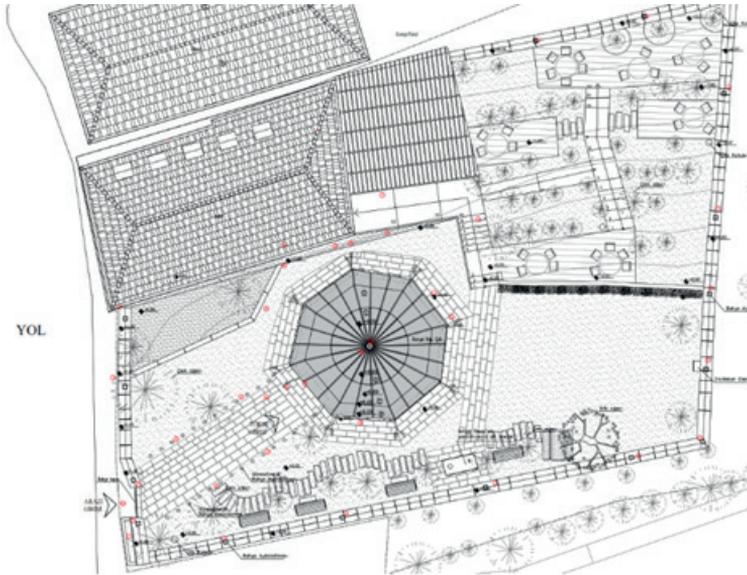
Figure 27. The site plan of the Ismail Dede Tomb restoration project

In the restitution project, the “entrance eave” was deemed as lacking in significance and was removed. In the restoration intervention, the removal of the entrance eave was also carried out. According to the preservation status analysis, no additional structural elements were suggested in the restitution project to replace the entrance eave. The decision to remove this structure was made based on the structural traces in the spatial configuration of the tomb and similar typological references. After the removal of the existing added entrance eave, it would be beneficial to repair the corroded parts of the body walls due to the eave with stones that match the original stone’s color and texture, fill the voided joints with appropriate mortar, and clean the surface dirt using a water spraying method. However, unlike in the restitution, an

additional feature, in the form of a fountain, located at the garden entrance to the west of this structure was considered valuable and was recommended for restoration and conservation (Figure 27). Therefore, in the restoration project, it was foreseen that the existing fountain's marbles would be repaired to match the current texture, color, and structure of the fountain, and the joints would be filled with appropriate mortar to continue its use. In the site plan shown in the restoration project, seating and lighting elements, garbage containers, and pedestrian paths were placed in the relevant locations. At the same time, dining and drinking platforms were designed and recommended to serve the meal activities among the worship rituals on the sloping wooded terrain to the east of the shrine. Furthermore, it was decided to fill the cracks in the known grave and stone of Ismail Dede's assistant located to the south of the shrine using appropriate mortar, along with the removal of plants and the filling of resulting gaps with suitable mortar. Cleaning of the stone surfaces was recommended using a water spraying method (Figure 27).

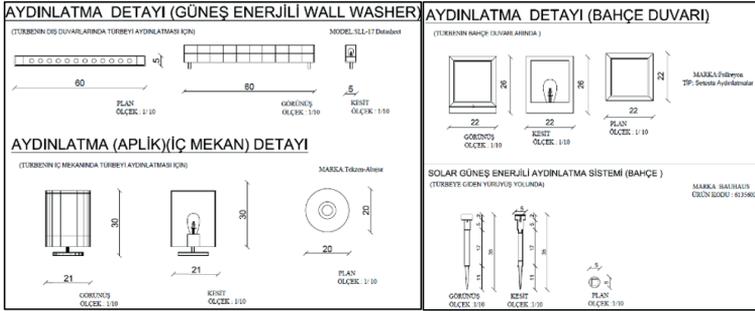
Figure 28. Ismail Dede Tomb restoration project site plan lighting elements

It has been decided to remove the electrical wiring that was pulled into the tomb from the garden, causing damage to the upper-level window frames, and to install a new electrical system (sockets, switches, etc.) without causing any harm to the traditional wooden flooring. Additionally, it is recommended to place energy-efficient lighting fixtures powered by solar energy in the relevant locations shown on the site plan of the restoration project (Figure 28).

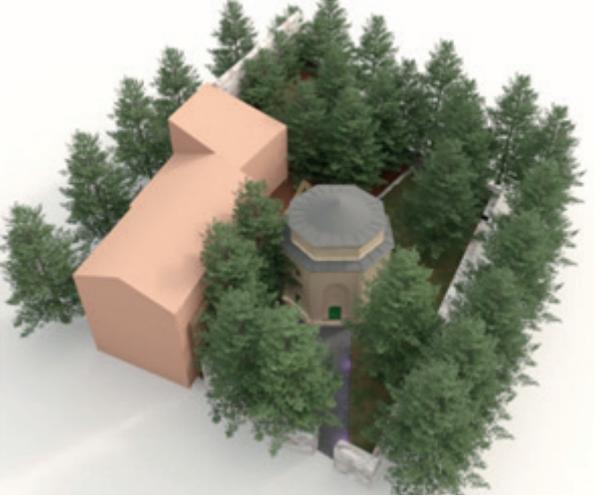
Figure 29. Ismail Dede Tomb Site Plan Restitution

In addition to all these interventions, it was decided to repair and repaint the existing garden gate. Furthermore, following the deterioration analysis, it was recommended to remove the plants in the areas where decisions were made in the restoration project and where the relevant locations are shown in the project. The voids left after removing the plants are to be filled with suitable mortar material that matches the original stone wall's color and structure. 3D models have been prepared in accordance with this recommendation (Figure 29, 30).

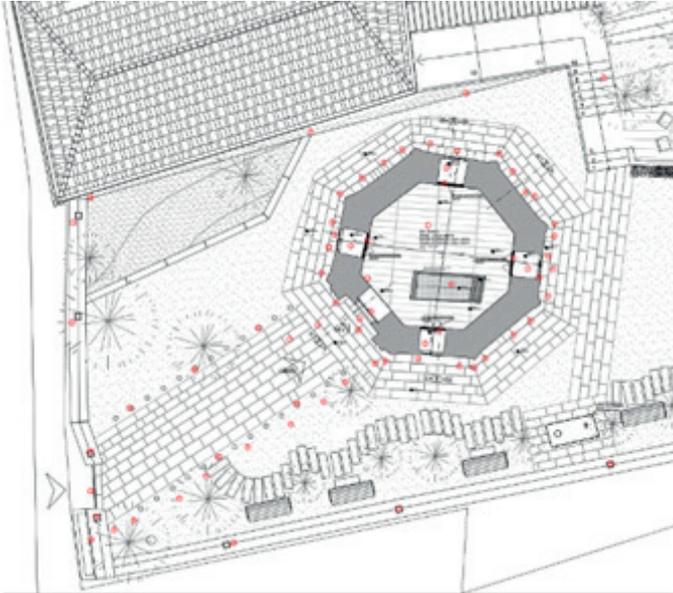
Figure 31. Ismail Dede Tomb Restoration Project Ground Floor Plan

It is recommended to perform repairs on the walls in the specified sections of the tomb space. The reproduction of the traditional wooden joisted flooring, as shown in the restoration project, is considered appropriate for the wooden cladding flooring on the ground. The decision was made to repair the hairline cracks that have formed in the floors of the window openings at +0.00 elevation, as defined in the projects, by injecting suitable mortar into the material. Additionally, it is recommended to repair the existing original wooden interior entrance door to match the material, texture, and color. With the removal of the added eave, it is suggested to replace the current wooden entrance door, which protects the wooden door from adverse weather conditions, with a glass door. The proposed door is intended to be frameless and made of glass material to minimize intervention in the façade (Figure 31).

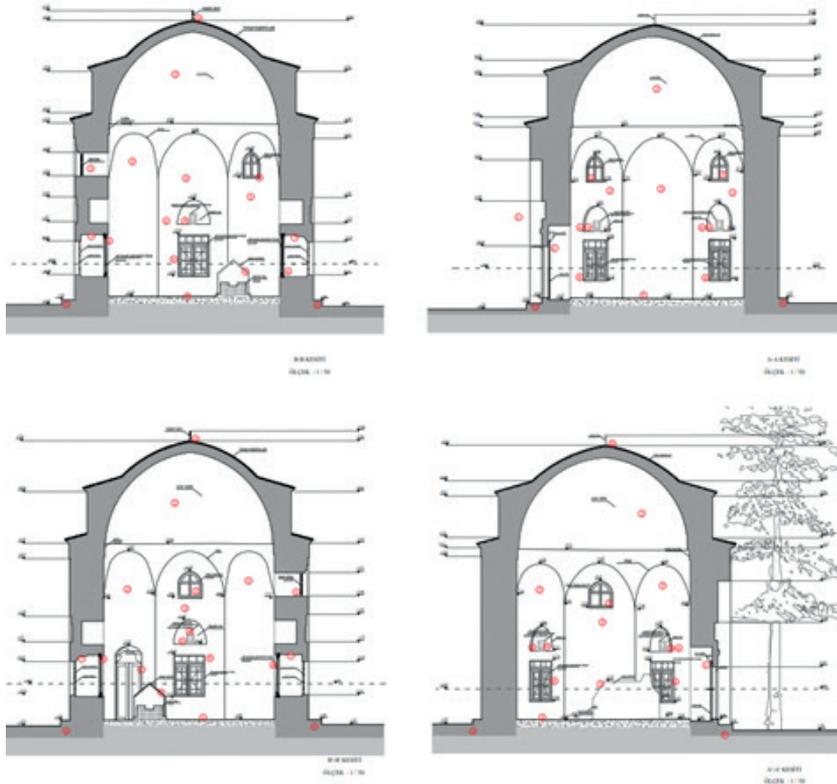
Figure 32. Sections of Ismail Dede Tomb Restoration Project

Within the context of the restitution project, it was determined that the lower-level window openings in the building had no frames, with only railings in these openings. However, the restoration project took into consideration the current usage. Therefore, to prevent the interior space from being affected by adverse weather conditions, a proposal was made to introduce traditional double-winged wooden windows that are in line with the typology after examining the windows

in the surrounding traditional context. Furthermore, as seen in the ceiling plan at +0.00 elevation, it was decided to repair the wear on the upper surface of the original wooden window and the cavity in a manner that matches the texture, color, and structure of the original material.

Additionally, it was decided to remove the electrical wiring that was pulled into the shrine from the garden, causing damage to the upper-level window frames, and to install a new electrical system (sockets, switches, etc.) without causing any harm to the traditional wooden flooring. Subsequently, considering the structure, texture, and color of the original material, it is recommended to reproduce the original wooden upper-level windows in line with their original state, which have deteriorated due to electrical wiring and natural causes (Figure 32).

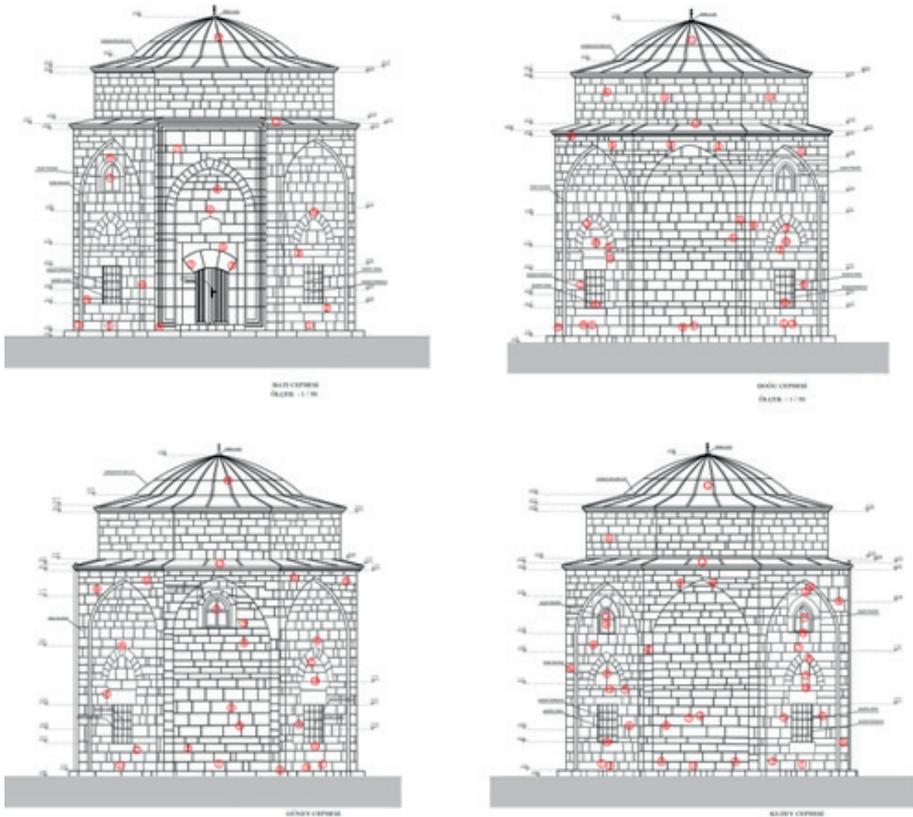
Figure 33. Ismail Dede Tomb Restoration Project Facades

The northeastern facade of the structure, which has eight facades, is mostly original, but there have been alterations and deterioration corresponding to user-induced material changes in the projecting canopy over the entrance facade, the non-original wooden entrance door, and the metal frames in the lower-level windows on all the facades. These mentioned architectural elements were added later to the structure and have been removed in the restitution project.

The application of cement-based fill material can be observed on the roof eaves and the body walls of the structure on all facades. Therefore, in the restoration project, it is envisaged that the cement-based material in the relevant areas shown will be rasped or removed, followed by the application of lime-based material for suitable filling or plaster. Additionally, there are capillary cracks on the northeastern and southeastern arch walls. Based on this consideration, it was decided to repair

the cracks by injecting appropriate mortar into the structure and, if necessary, to remove the stone material and reposition it to achieve the surface level. Additionally, partial joint loss is observed on the northeast, northwest, west, and south facades, while there is surface loss in stone material and joints in the blind arches on the east and north facades. Therefore, it is recommended to repair the walls of the building according to the appearance of the restoration state. During this process, attention should be paid to the material, color, structure, and texture of the original stone walls, and the joint voids in the walls should be filled by injecting suitable mortar. Furthermore, due to material deterioration caused by moisture, it is recommended to strengthen the north walls, ensuring better integrity. For this purpose, the stones that make up the walls should be removed and numbered, galvanized steel meshes should be installed, and they should be covered with lime mortar (Pozolanic lime-based, cementless, high-strength repair mortar, compressive strength > 15MPa) according to the static report. After this application, the stones that were removed should be reassembled based on the numbering and the restitution project. This practice is also anticipated to be a remedial measure for enhancing the overall structural integrity of the building and improving its performance under potential external forces. Strengthening the load-bearing walls with steel mesh reinforcement is expected to not only increase the general structural capacity of the building but also improve its resistance to out-of-plane forces, as well as enhance load sharing. Partial color change on the stone materials due to flawed repairs above the crown door on the west facade, as well as partial soiling on the stone materials at the ampatman level on the northeast, southeast, south, and southwest facades, as well as on the body walls immediately above, have been observed. Therefore, it is recommended to perform repairs on the original stone materials, considering their color, structure, material, and texture, and to clean the discoloration and soiling on the voussoirs using the water spraying method. Similar issues related to material deterioration due to groundwater are present in the body walls at the ampatman level on these facades. Hence, it is recommended to resolve the moisture issue originating from the ground by conducting drainage to divert water away from the building both from the roof and the ground. This process involves numbering the stones before their removal for drainage placement, and subsequently returning the numbered stones into their original positions after the completion of the process.

In the context of the restitution project, it was noted that the lower-level window openings in the structure are frameless, with only railings. However, taking

into account the current usage within the restoration project, the examination of traditional windows in the surrounding area suggested the addition of traditional double-wing wooden windows that are in line with the typology to these window openings. Furthermore, for the upper-level original wooden windows and openings, a decision was made to repair the wear and tear on the upper surface of the wooden cladding in line with the texture, color, and structure of the original material. In consideration of the structure, texture, and color of the original material, it was recommended to reproduce the original state of the original upper-level windows that have been subjected to damage due to electrical installations and natural factors.

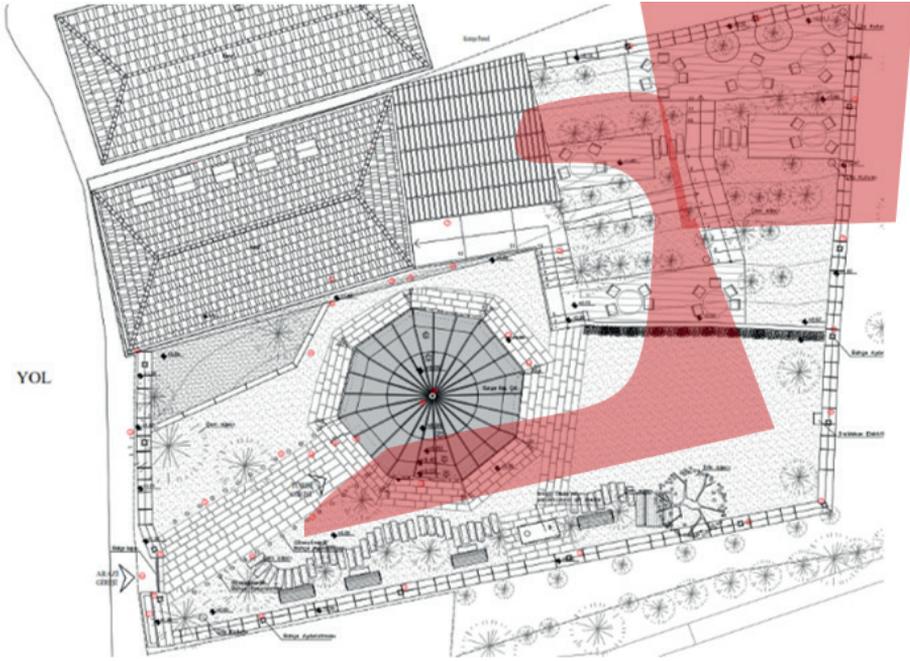
Figure 34. The İsmail Dede Tomb Restoration Project Site Plan Intervention Areas

During the project’s preparation, structural interventions were heavily considered, but no changes were made to the function. It was decided to maintain the original function of the tomb, while also making recommendations for open spaces within the tomb’s premises to serve ethnic and religious rituals. Based on this idea, the restoration project incorporated seating and lighting elements, trash bins, and walking paths into the relevant locations as indicated on the site plan. Additionally, dining and drinking platforms were designed and suggested for the sloped, treed area to the east of the structure to facilitate meal-related activities during worship rituals (Figure 34).

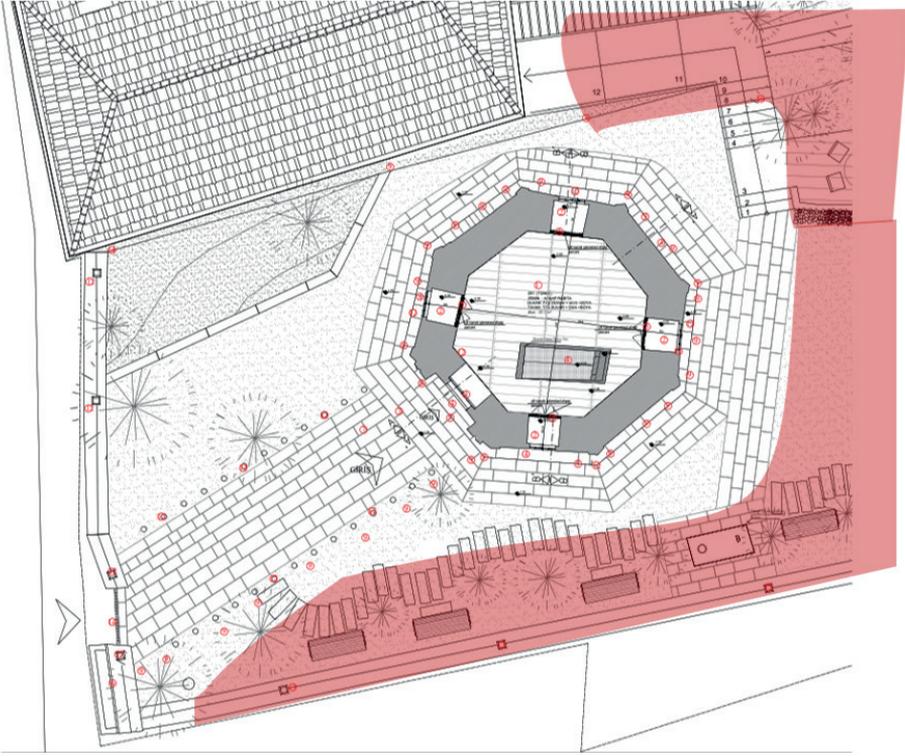
Figure 36. The İsmail Dede Tomb Restoration Project, Ground Floor Plan, Intervention Areas

In terms of conservation theory, it is believed that translating a restoration decision into practice without having sufficient precise information, to achieve stylistic unity, would be more of a hypothetical application. Therefore, a state of conservation analysis and restitution projects have been prepared. Based on these analyses, a restoration project has been developed. In this context, the comprehensive repairs needed for the structure include addressing the issues of sliding in the garden retaining wall and dampness in the ground, providing access from the tomb to the kitchen, removing the existing entrance overhang and rectifying the damages it has caused, addressing the voids in the stone material on the ground, and arranging the tomb garden to serve religious rituals. Apart from these issues, there are no major deteriorations in the structure that require extensive restoration (Cleansing, Demolition, Dismantling- Reinforcement, Integration- Reconstruction, Renewal). Most of the structural elements in both the original and period-specific sections of the building are mostly original, and there is no significant structural deterioration present (Figure 36).
